MOSUL AIR TRAFFIC CONTROL
TOWER AND NAVIGATIONAL AIDS
MOSUL, IRAQ

SIGIR PA-06-034

APRIL 25, 2006

SUBJECT: Report on Project Assessment of the Mosul Air Traffic Control Tower and Navigational Aids, Mosul, Iraq (Report Number SIGIR-PA-06-034)

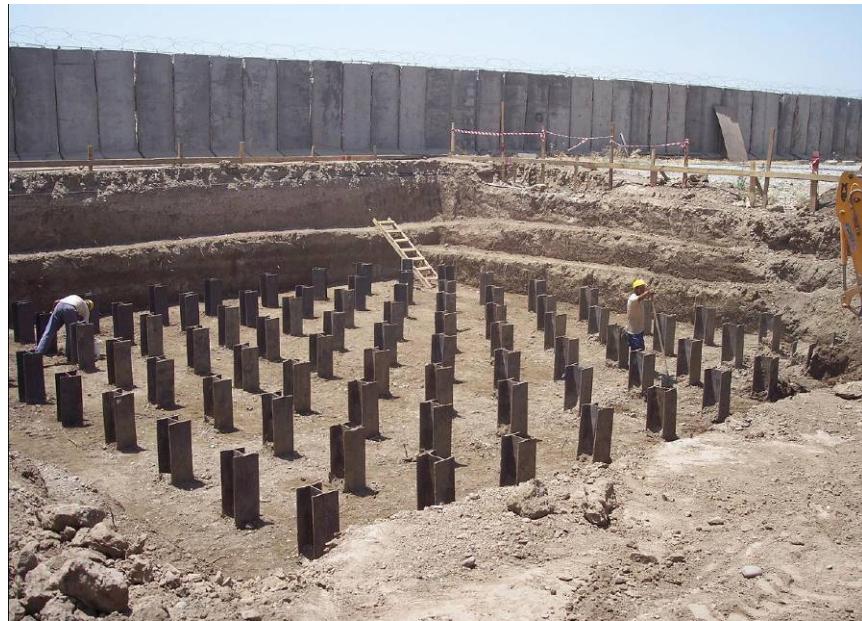
Site Photo 1 shows the piles in place after completion of the pile driving operations. Site Photo 2 shows steel reinforcement positioned above the piles prior to concrete placement. Although we were not present to observe any of the foundation construction, which took place months earlier, our review of the site photos and daily Quality Control (QC) reports indicate the foundation was constructed properly in accordance with the contractor's design.

Site Photo 1. Foundation construction with steel piles
- Photo provided by USACE

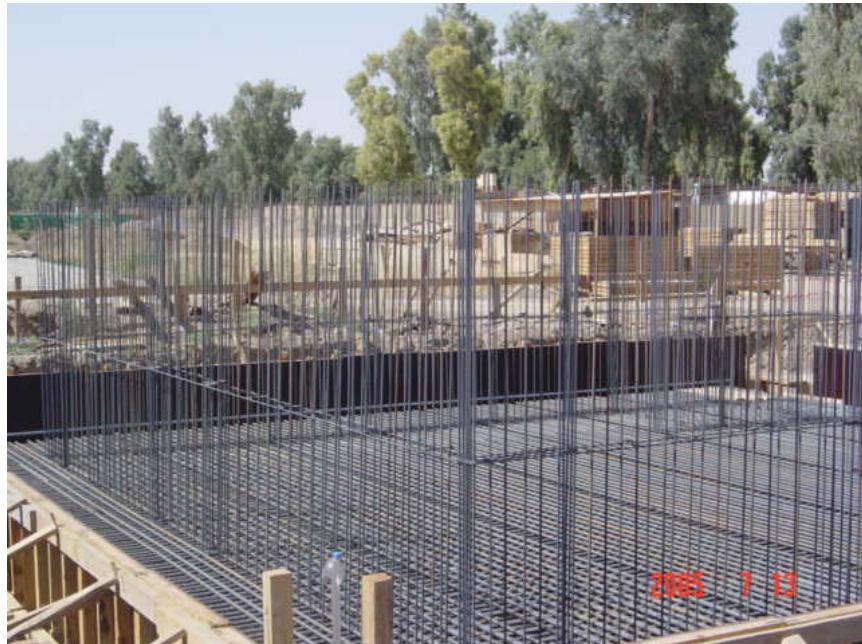
Site Photo 2. Reinforcement installation for foundation
- Photo provided by USACE

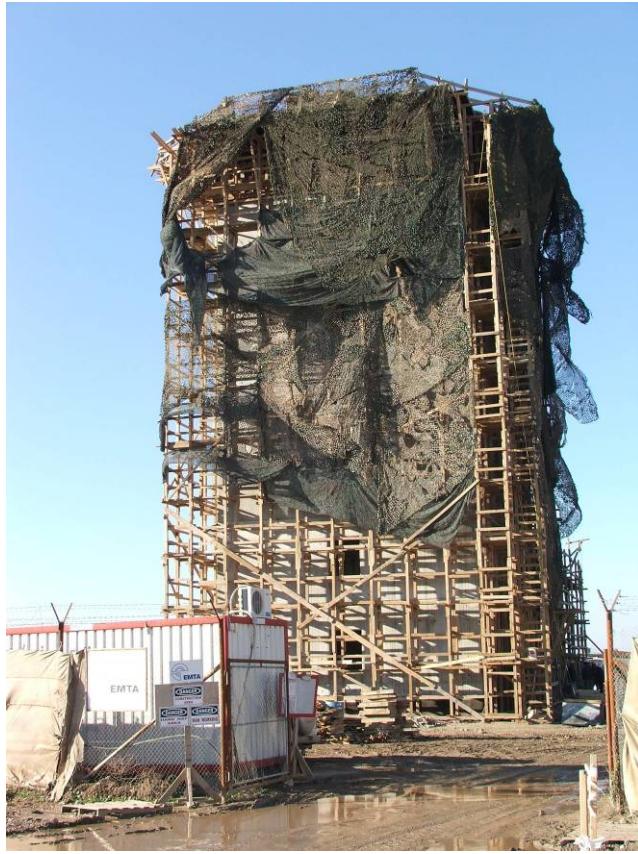
Site Photo 3. The ATC tower south elevation

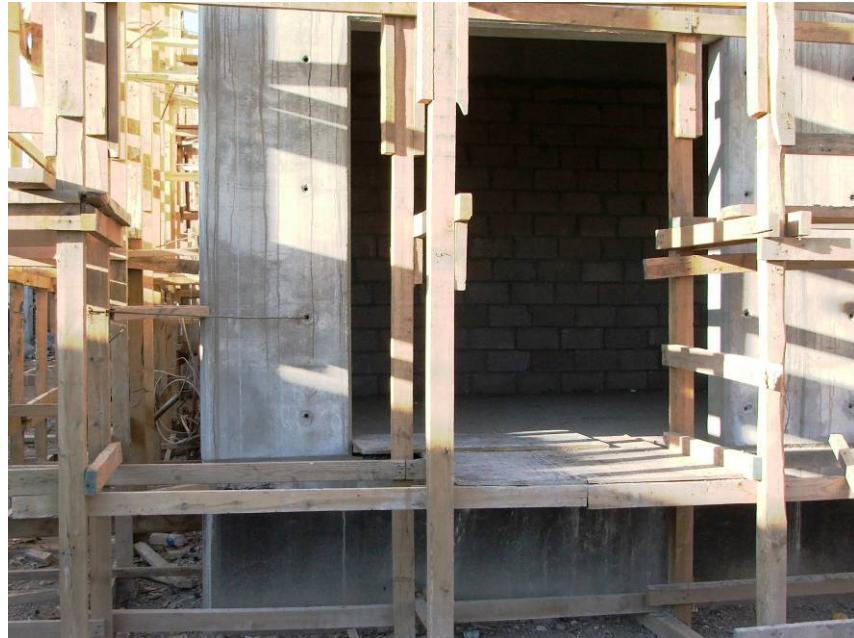
For an example of the ground floor construction, refer to Site Photo 4, which shows the door opening into the ground floor electrical room. For an example of the interior construction on one of the upper floors, refer to Site Photo 5, which shows the reinforced concrete walls and ceiling slab typical of what we found in the tower.

Site Photo 4. Ground floor electrical room in the ATC tower building

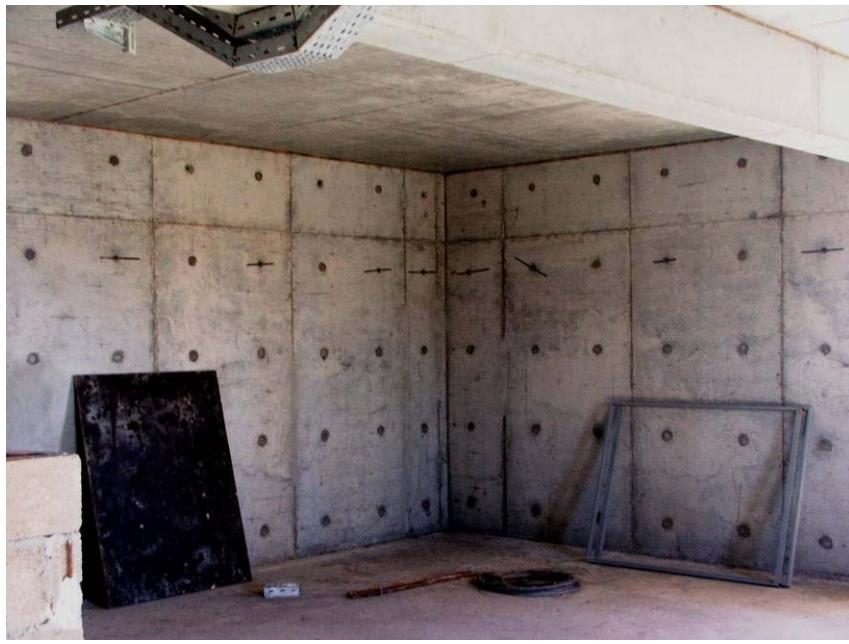
Site Photo 5. Reinforced concrete walls, floor, and ceiling in the ATC tower

Site Photo 5 is representative of the high quality of workmanship of the reinforced concrete work in the ATC tower facility. The finish of the concrete surfaces was smooth and devoid of any noticeable defects such as segregation or honeycombing.

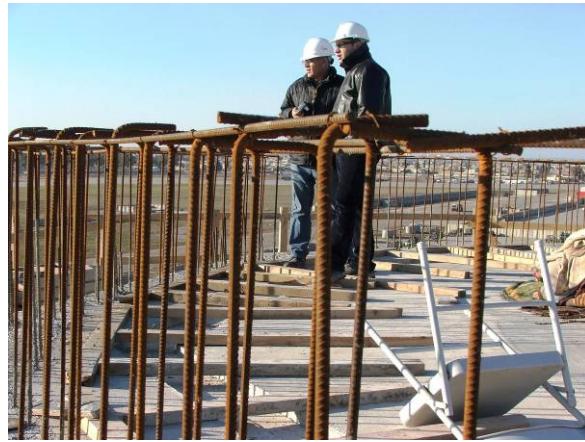
At the time of our site visit, the reinforced concrete base supporting a portion of the tower cab including the walkway was in place, but the cab had not yet been installed. Site Photos 6 and 7 show the concrete base for the tower cab and the walkway that will circle the cab. The reinforcing steel shown in each picture is part of the 1 m high reinforced concrete base that will support another part of the tower cab.

Site Photo 6. ATC tower concrete base

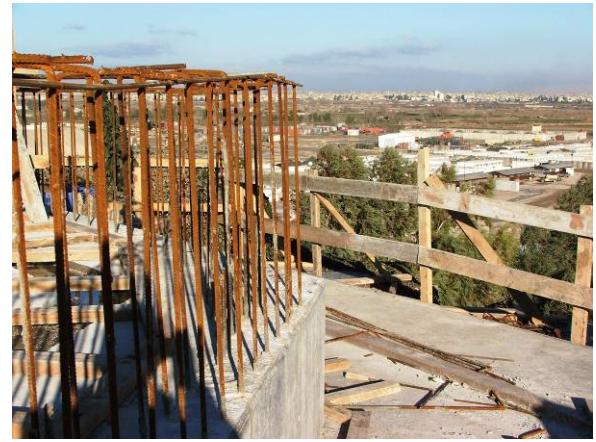
Site Photo 7. Concrete walkway

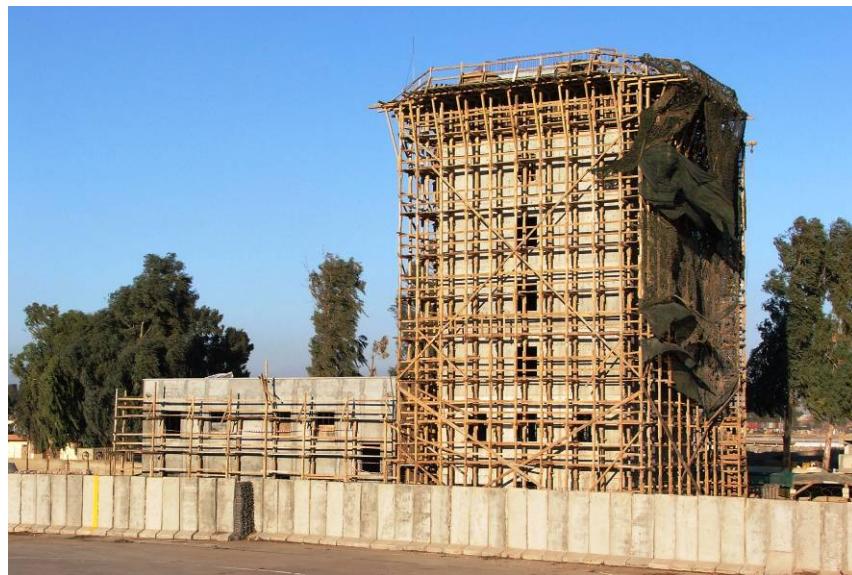
Site Photo 8. The exterior of the ATC tower facility

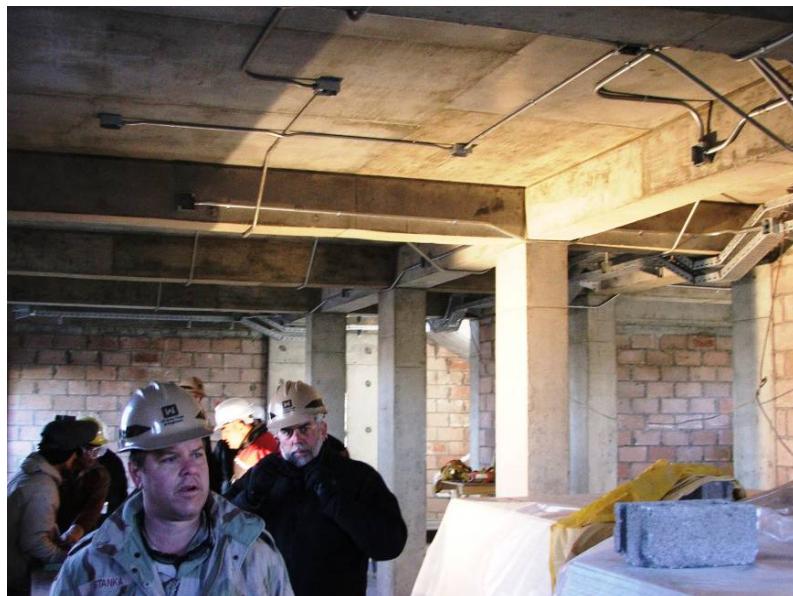
a plaster coating and painted. At the time of our site visit, the structural frame and exterior walls had been constructed and the contractor was working on plastering the exterior. Electrical conduit and cable raceways were being installed in the interior. Site Photo 9 shows the CMU walls, reinforced concrete columns, beams and roof slab in the ground floor area. The photo also shows electrical conduit and cable raceways being installed and anchored to the concrete.

Site Photo 9. Ground floor in the ATC tower administration building

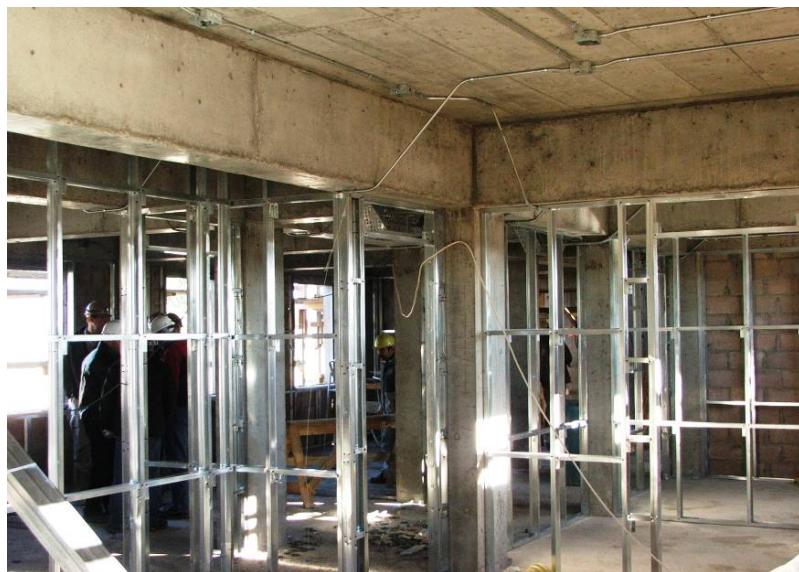
We also observed interior wall construction during the site visit. Site Photo 10 shows the metal studs in place for office walls located in the first floor.

Site Photo 10. Interior wall construction in the ATC tower administration building

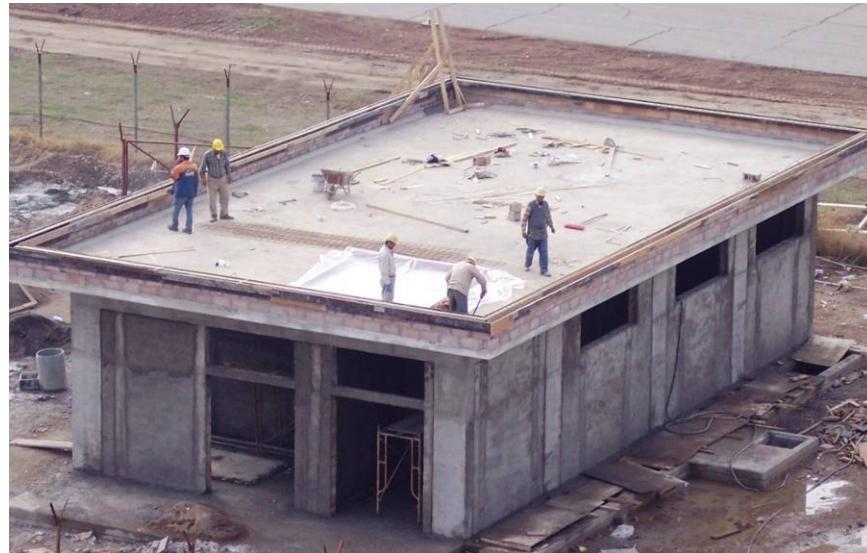
The same building design was utilized for each substation. The substations were designed as a single level, 8.8 m by 16.5 m rectangular reinforced concrete structure with exterior and interior concrete block walls as shown in Site Photo 11.

Site Photo 11. Substation 1 during construction –Photo provided by USACE

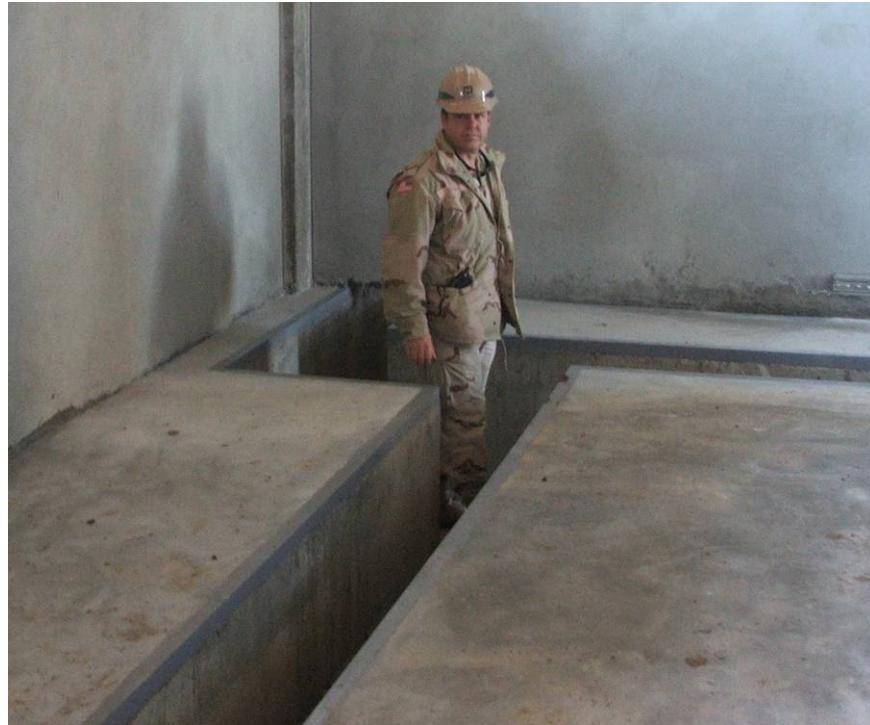
The floor plan included a room for electrical switchgear, as well as separate rooms for controls, a transformer, and a generator. To accommodate the placement of electrical cables and connection to equipment, recessed raceways were located in the concrete floors. Site Photo 12 shows the raceways.

Site Photo 12. Recessed cable raceways in the substation

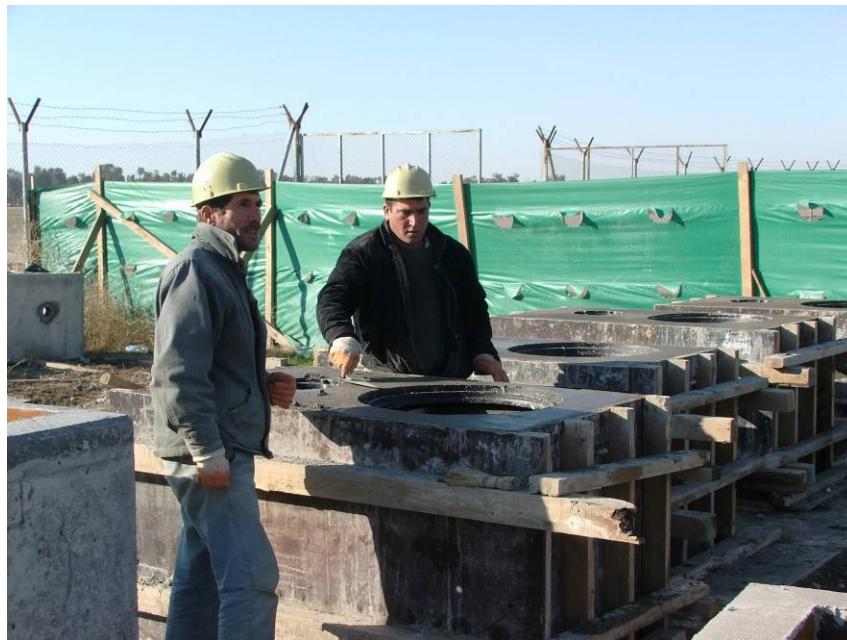
lighting systems. Site Photo 13 shows the pre-cast operation for constructing the hand holes and Site Photo 14 shows a hand hole in place along the taxiway and also shows the mounting enclosure for the taxiway luminaries.

Site Photo 13. Pre-cast concrete hand holes being constructed

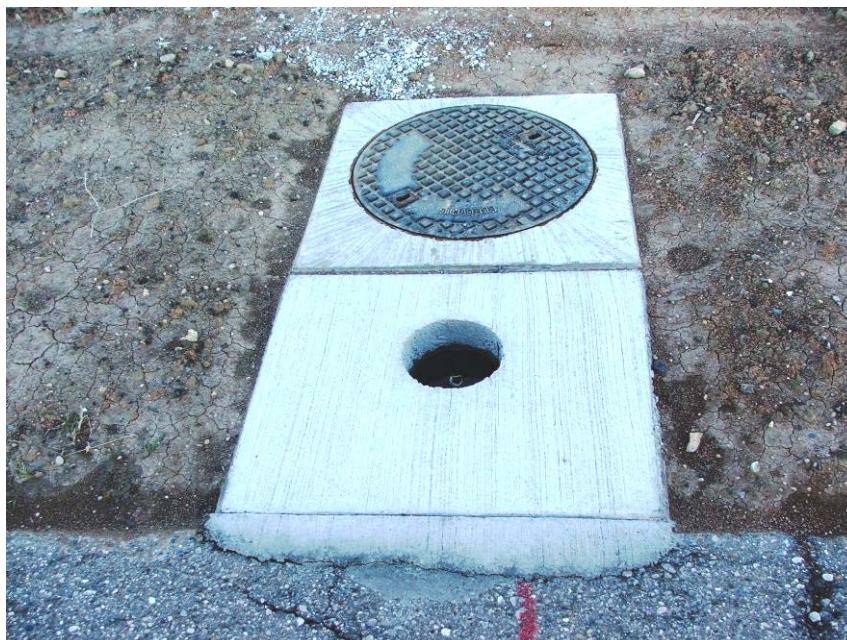
Site Photo 14. Hand hole installed along taxiway edge of pavement

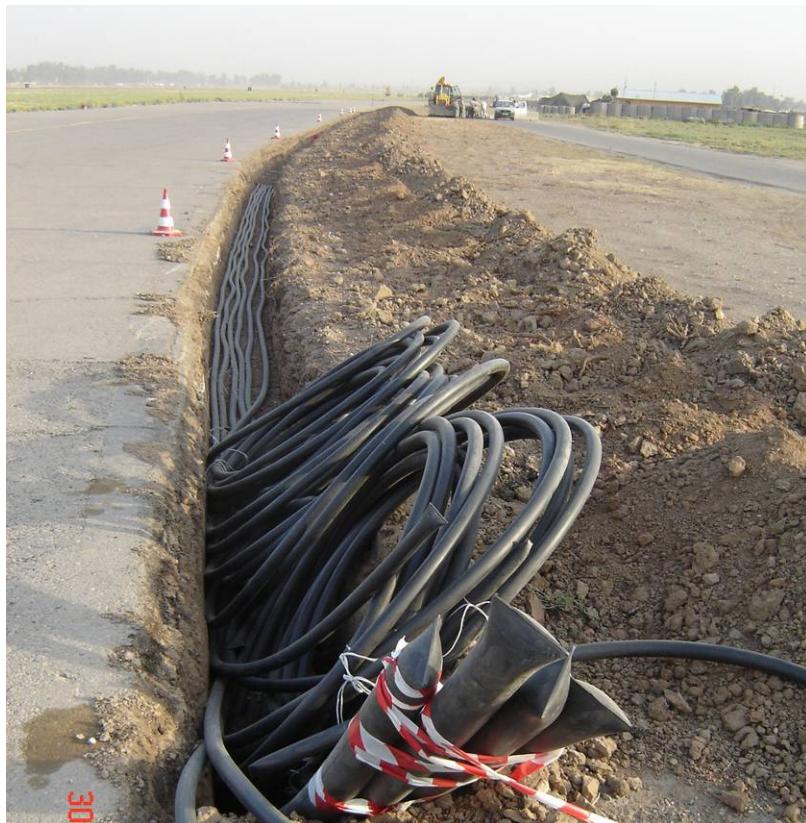
The luminaries for taxiway and runway edge lighting were required to be installed onto breakaway mountings. The design also required the electrical cable connecting the lights and other NavAids to the power source to be encased in PVC conduit. Site Photo 15, provided by the USACE, shows the trenching and PVC conduit installation for various NavAids, including taxiway edge lighting.

Site Photo 15. Conduit installation for NavAids – Photo provided by USACE

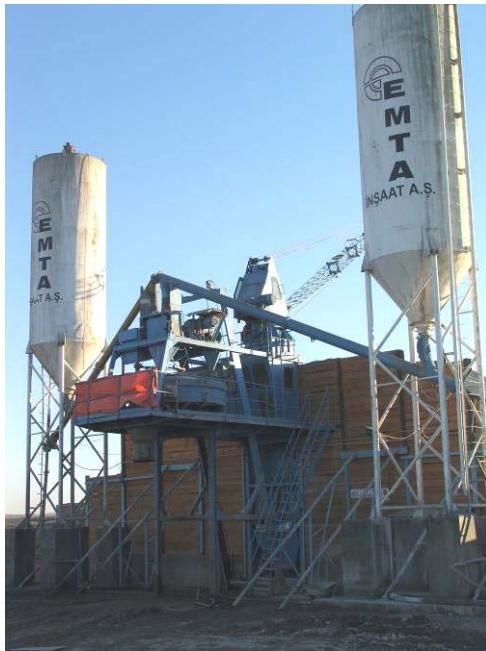
A significant component of the ATC tower facility included structural concrete. The amount of concrete needed to construct the facility necessitated the utilization of materials, equipment, and processes that could produce consistent mix proportions when batching concrete. To meet the demand for high quality structural concrete, the contractor erected a concrete batch plant near the construction site on an adjacent FOB. The batch plant, shown in Site Photos 16 and 17, included two cement silos, separate stockpiles for coarse and fine aggregate, a water storage tank, and automated controls for mixing materials.

Site Photo 16: Concrete batch plant

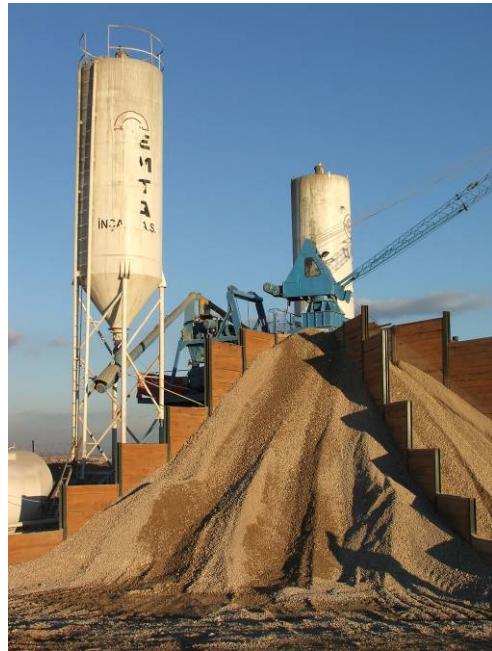
Site Photo 17. Aggregate stockpiles
